INDIANA DEPARTMENT OF ENVIRONMENTAL MANAGEMENT

SITE REASSESSMENT REPORT

METALS REFINING COMPANY

January 28, 2010 (revised)

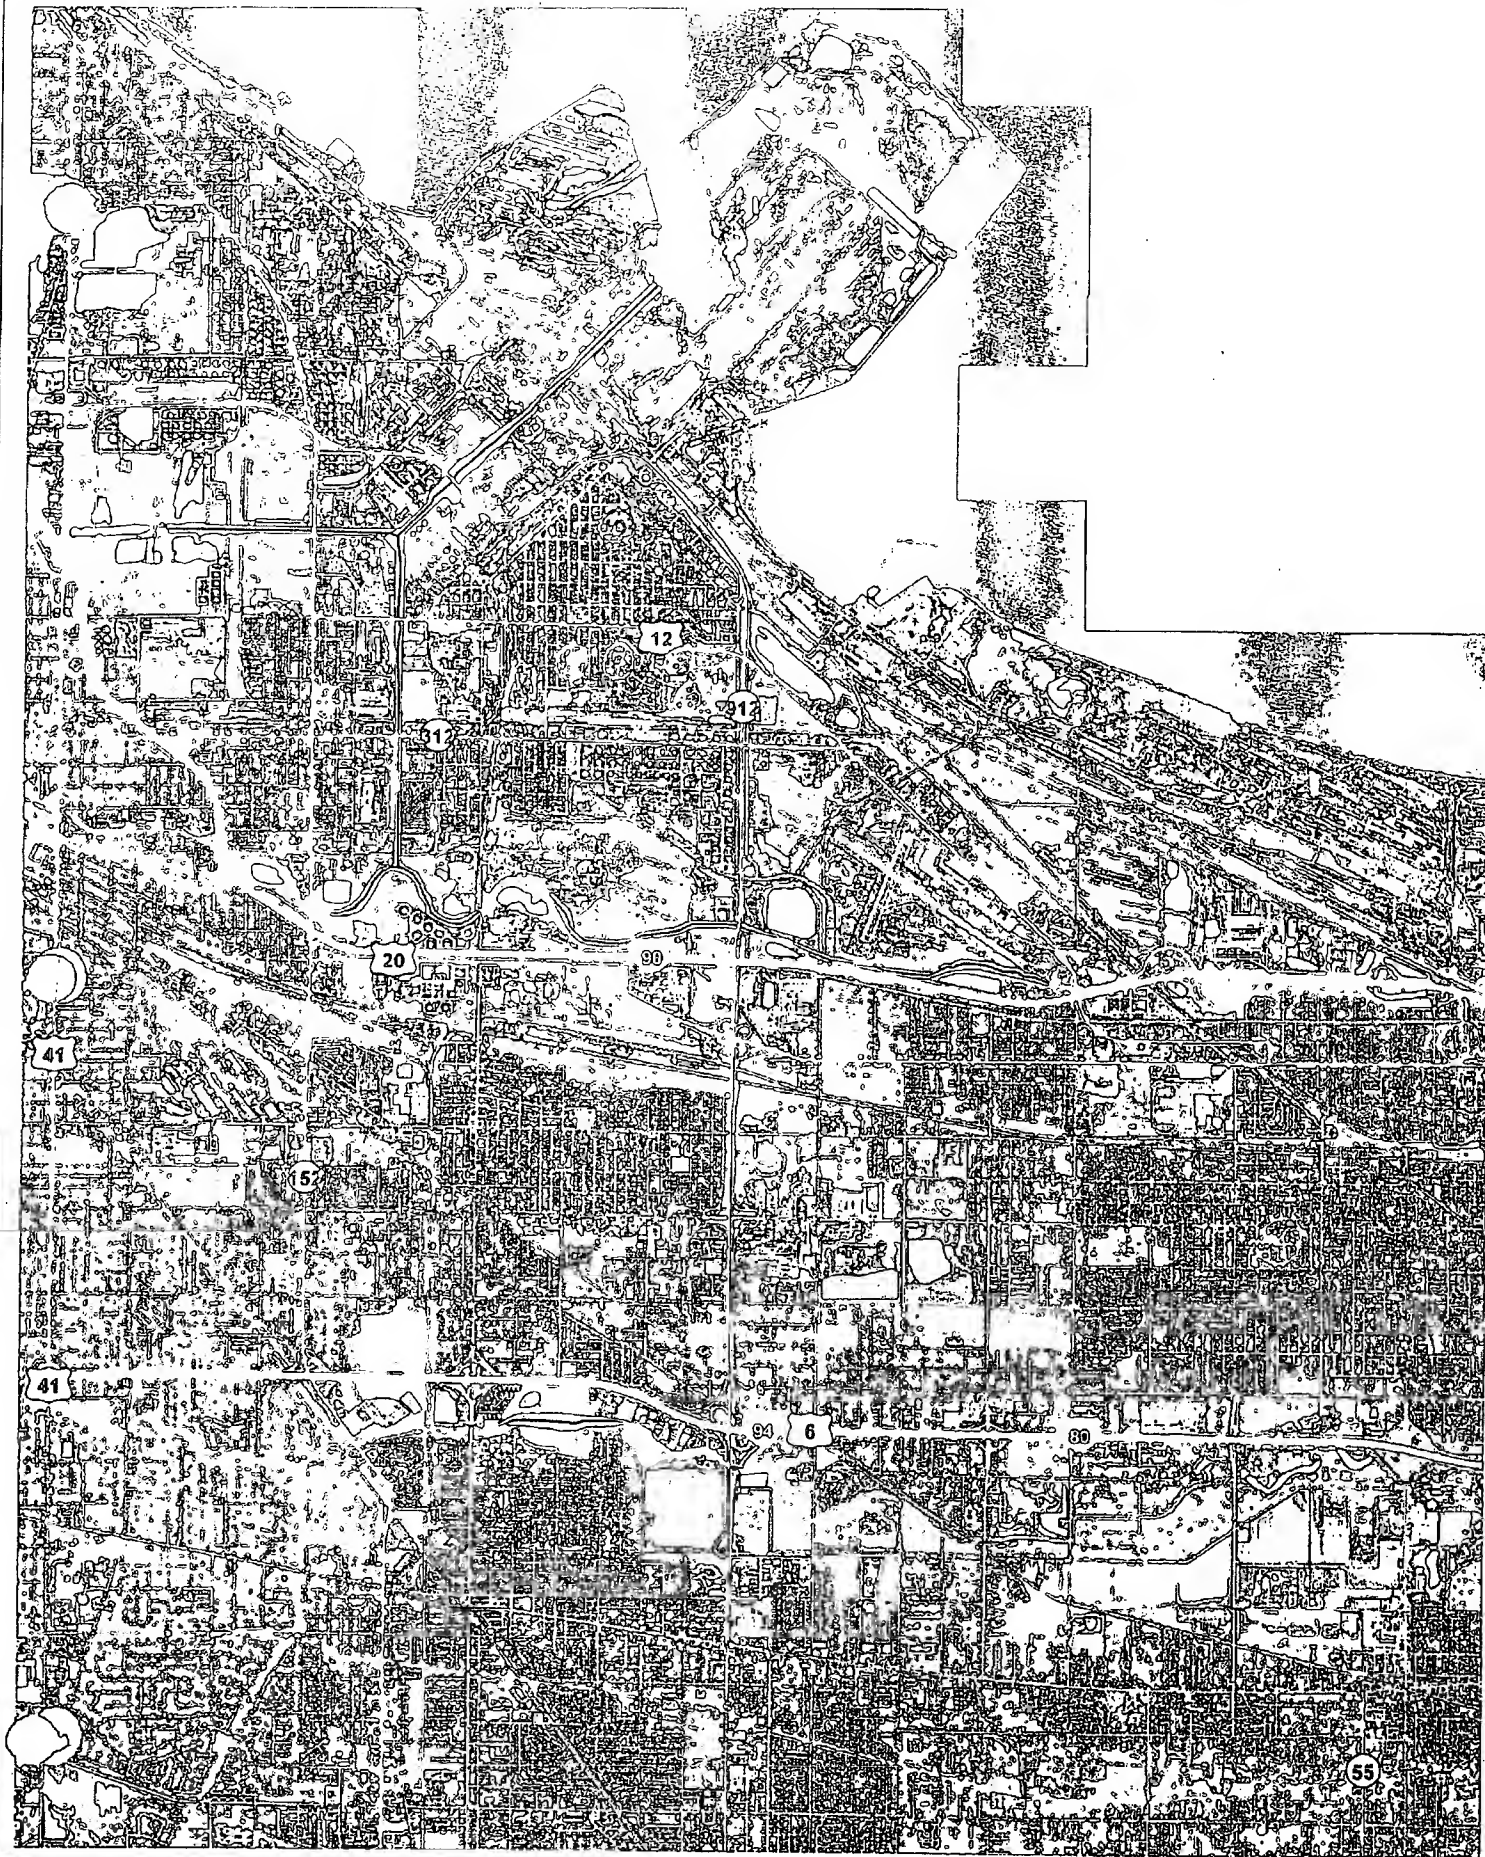
U.S. SMELTER AND LEAD RESIDENTIAL  
Background Sampling

- 1) Kosciusko Park  
South side of 151<sup>st</sup> Street  
@ Baring Avenue or  
Northcote Avenue (ball diamond)
- 2) Small Park  
Northeast corner of 150<sup>th</sup> Street  
and Magoun Avenue
- 3) School Athletic Field  
Southwest corner of Chicago (312)  
and 2<sup>nd</sup> White Oak Avenue

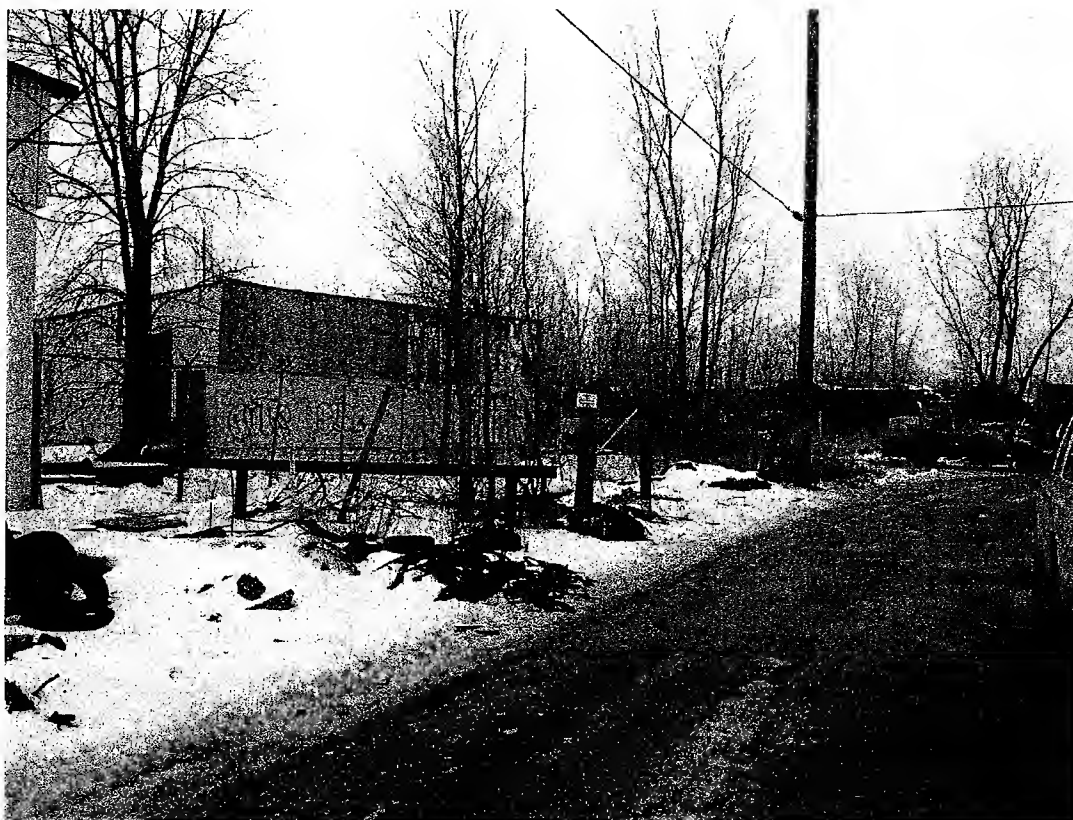
Site:	Metals Refining Site
Site ID:	INN000509964
Date:	1/19/10
Weather:	Cloudy, Cold
Description:	East side of Metals Refining Facility from Hump Road facing North

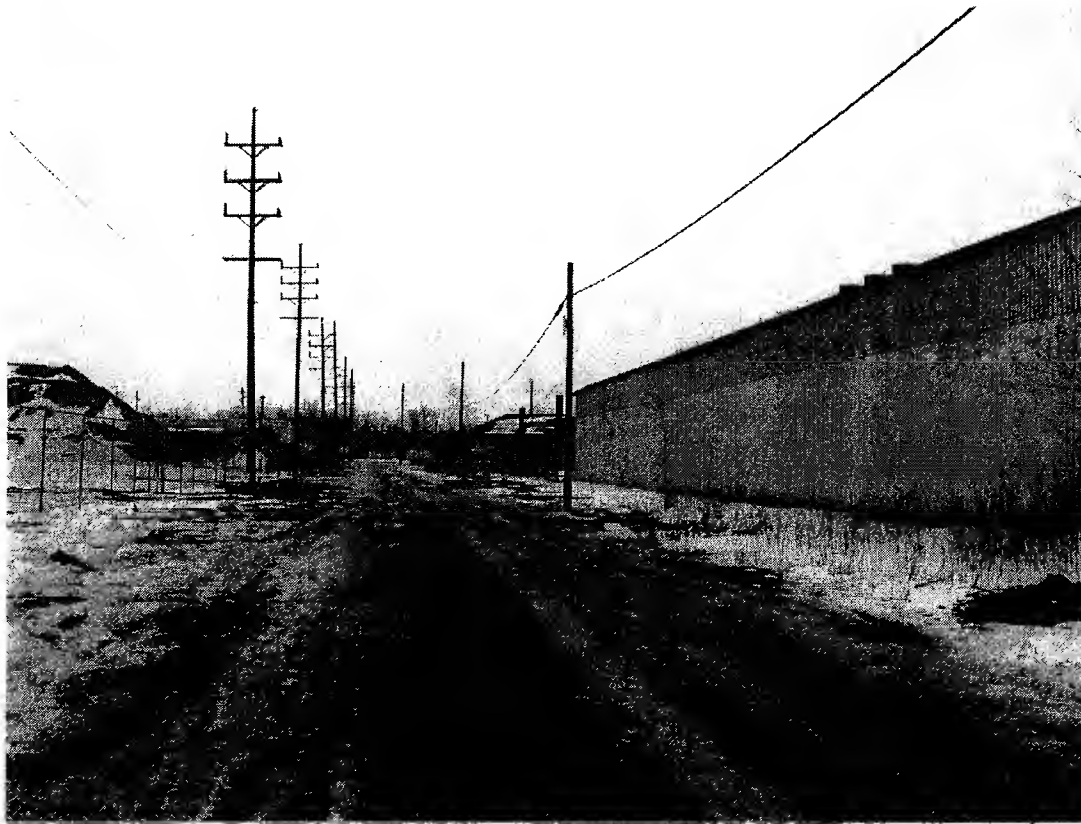
Site:	Metals Refining Site
Site ID:	INN000509964
Date:	1/19/10
Weather:	Cloudy, Cold
Description:	East side of Metals Refining Facility from Hump Road facing South

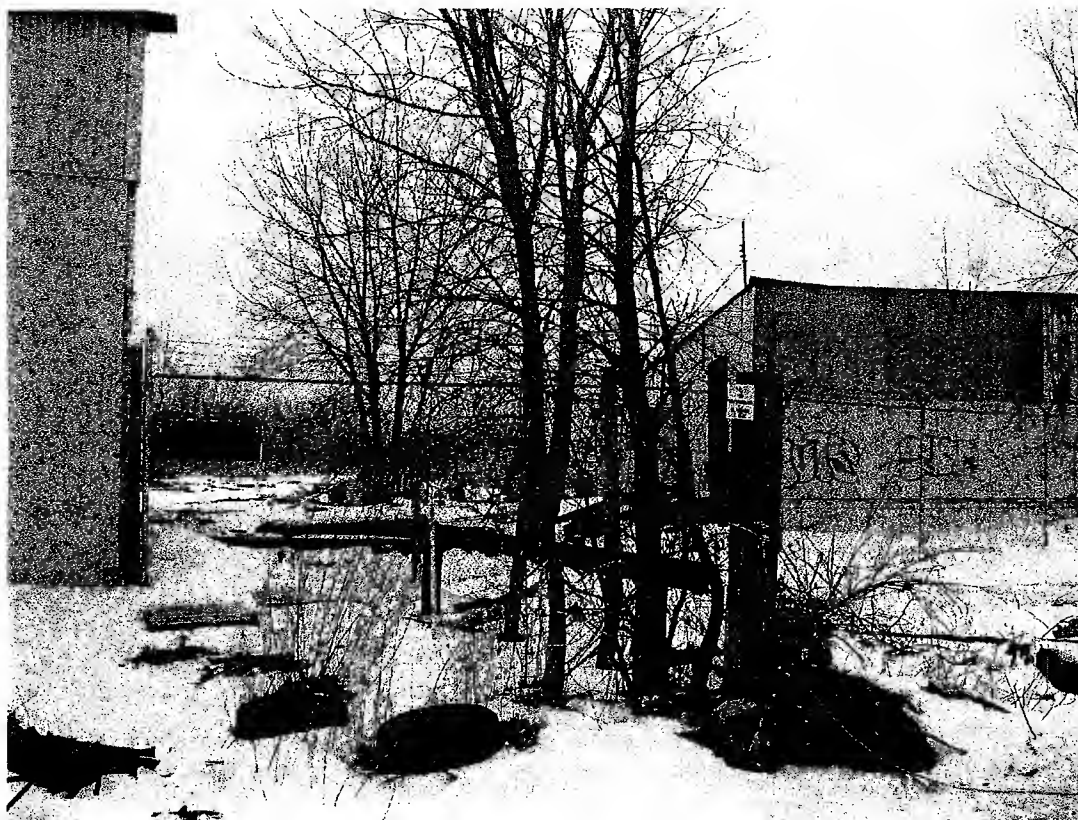
Site:	Metals Refining Site
Site ID:	INN000509964
Date:	1/19/10
Weather:	Cloudy, Cold
Description:	East side of Metals Refining Facility from Hump Road; random debris

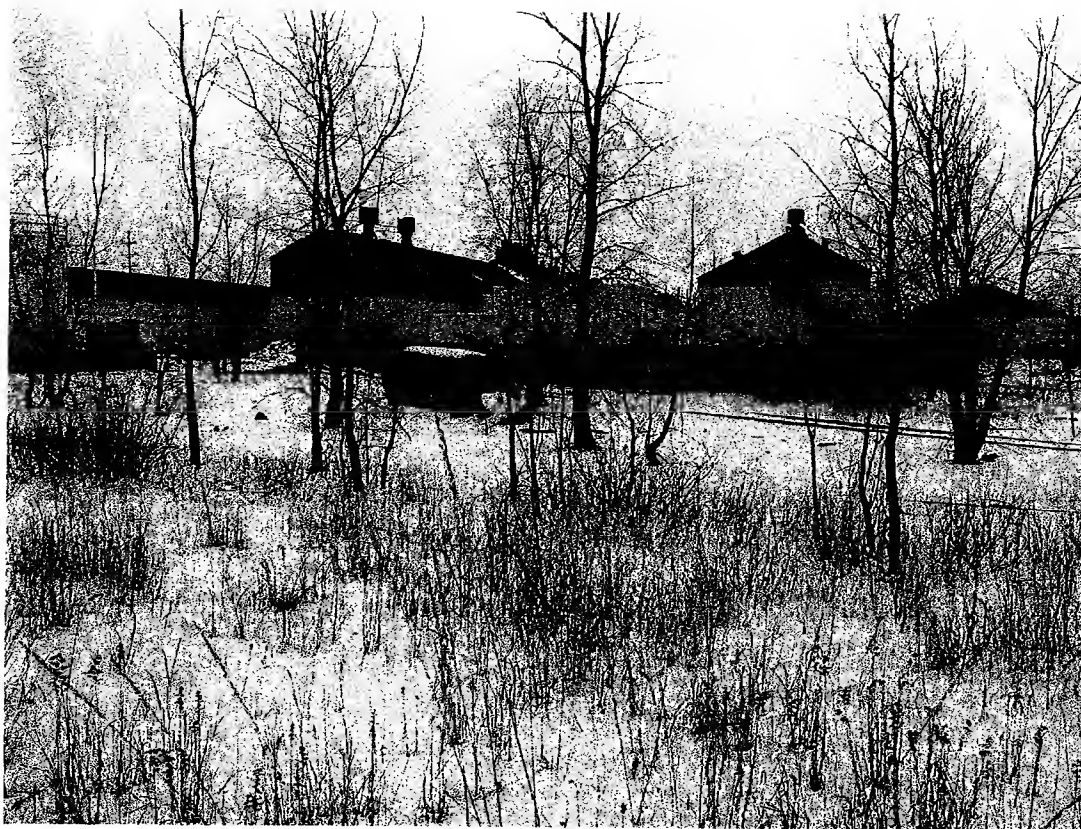
Site:	Metals Refining Site
Site ID:	INN000509964
Date:	1/19/10
Weather:	Cloudy, Cold
Description:	Photo taken from Northwest portion of property looking south

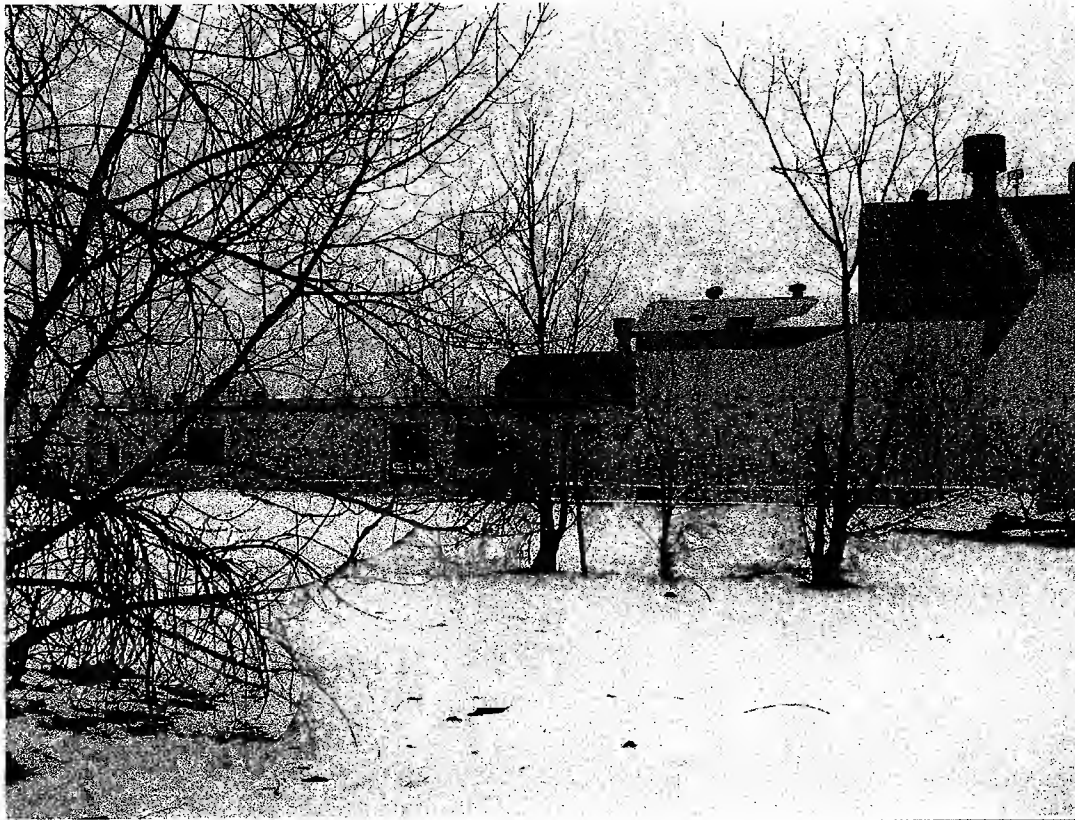
Site:	Metals Refining Site
Site ID:	INN000509964
Date:	1/19/10
Weather:	Cloudy, Cold
Description:	Main building complex in South central portion of property

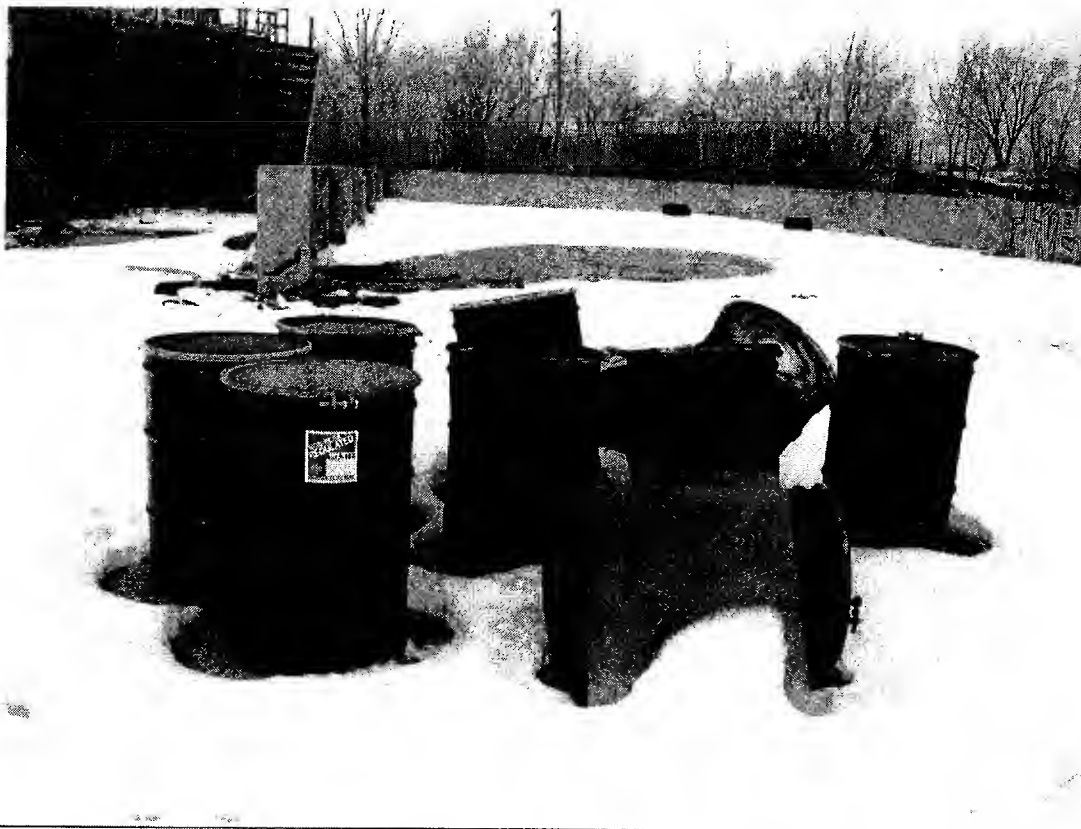
- 1) The Metals Refining facility was completely fenced, but had large sections of fence removed on the east and north sides of the property.
- 2) The buildings at the site were in various stages of decay and covered with graffiti. (Site Photos, Appendix K)
- 3) A small pile of tires and inner tubes were discovered on the east side of the property next to one of the buildings.
- 4) One of the buildings in the eastern portion of the property contained several 5 gallon buckets that appeared to have various chemicals in them.
- 5) Several drums were discovered in the north central portion of the property.

Site:	Metals Refining Site
Site ID:	INN000509964
Date:	1/19/10
Weather:	Cloudy, Cold
Description:	Drums in center of property

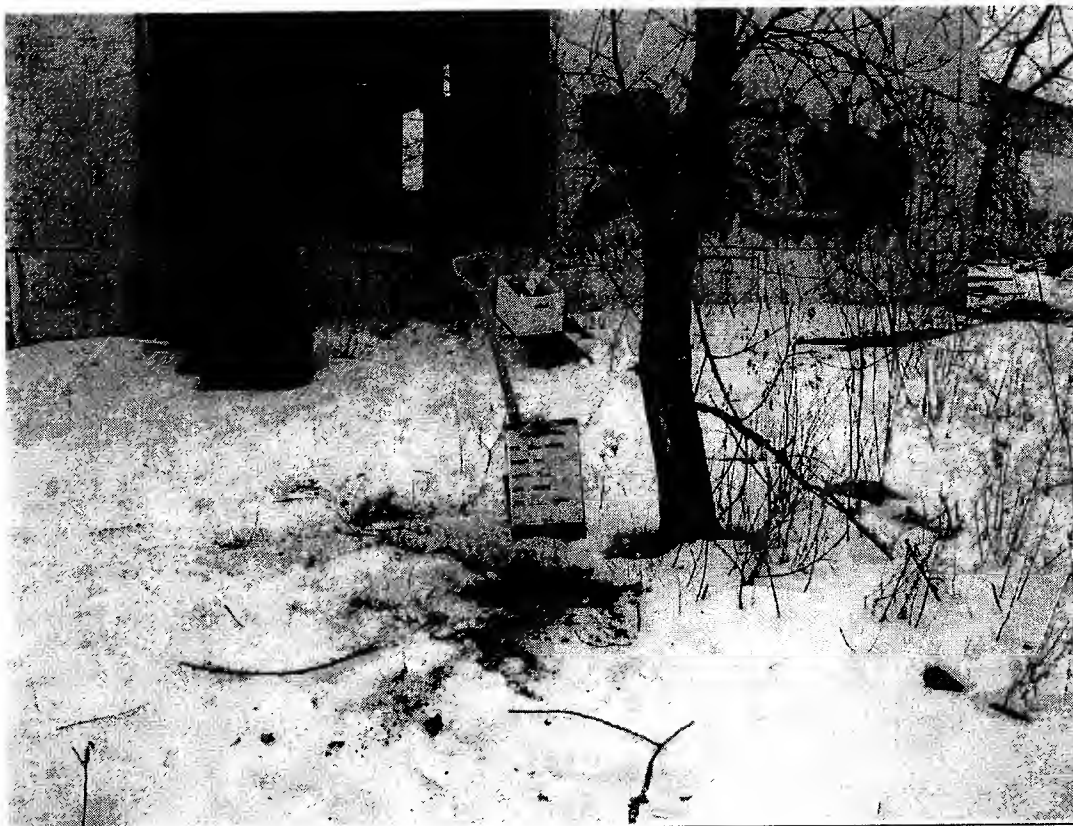
Site:	Metals Refining Site
Site ID:	INN000509964
Date:	1/19/10
Weather:	Cloudy Cold
Sample ID:	OS2
Sample Type:	XRF Soil Screening Sample
Description:	Sample was collected on the North central portion of property

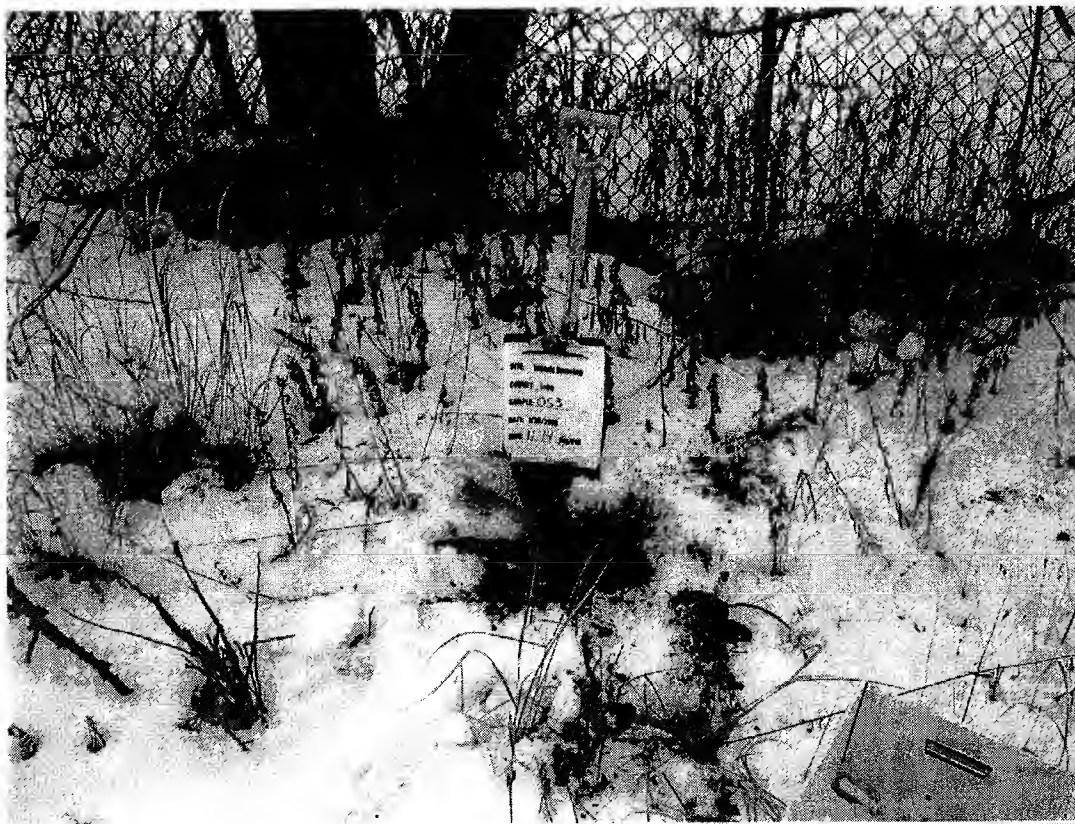
Site:	Metals Refining Site
Site ID:	INN000509964
Date:	1/19/10
Weather:	Cloudy Cold
Sample ID:	OS3
Sample Type:	XRF Soil Screening Sample
Description:	Sample was collected on the North West portion of property

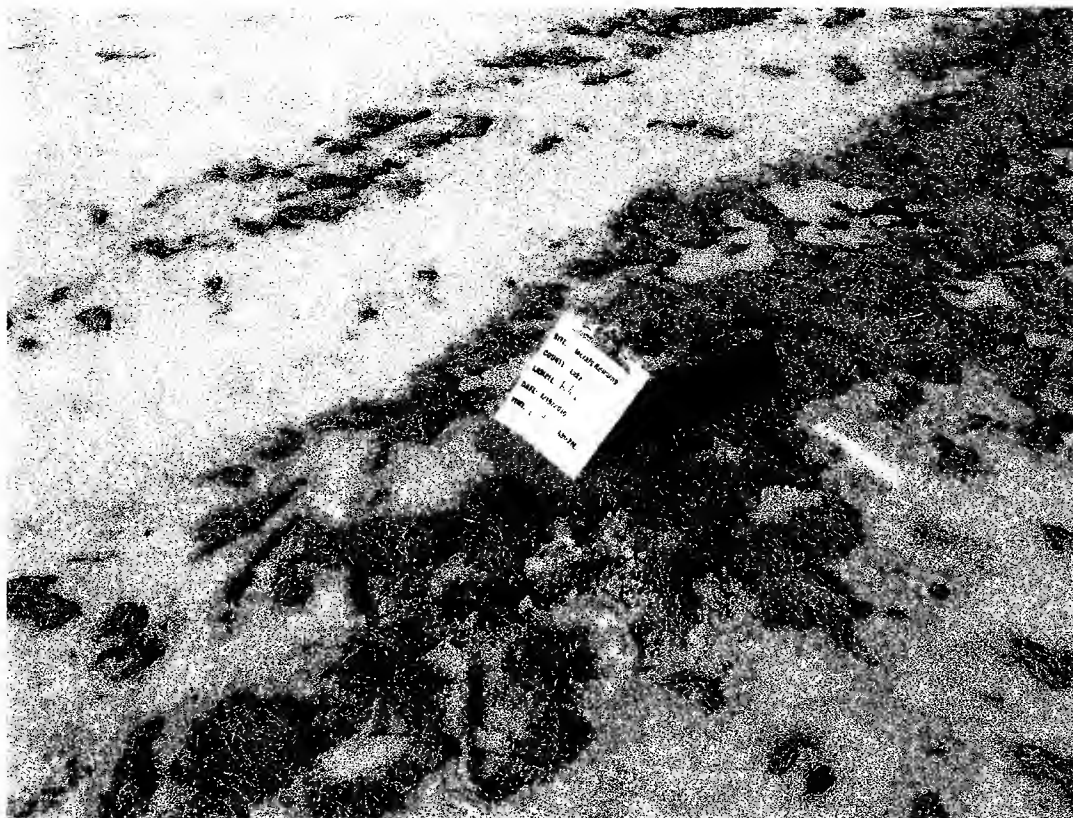
Site:	Metals Refining Site
Site ID:	INN000509964
Date:	1/19/10
Weather:	Cloudy Cold
Sample ID:	BK5
Sample Type:	XRF Soil Screening Sample
Description:	Sample was collected at the corner of Columbia and Kenwood Streets.

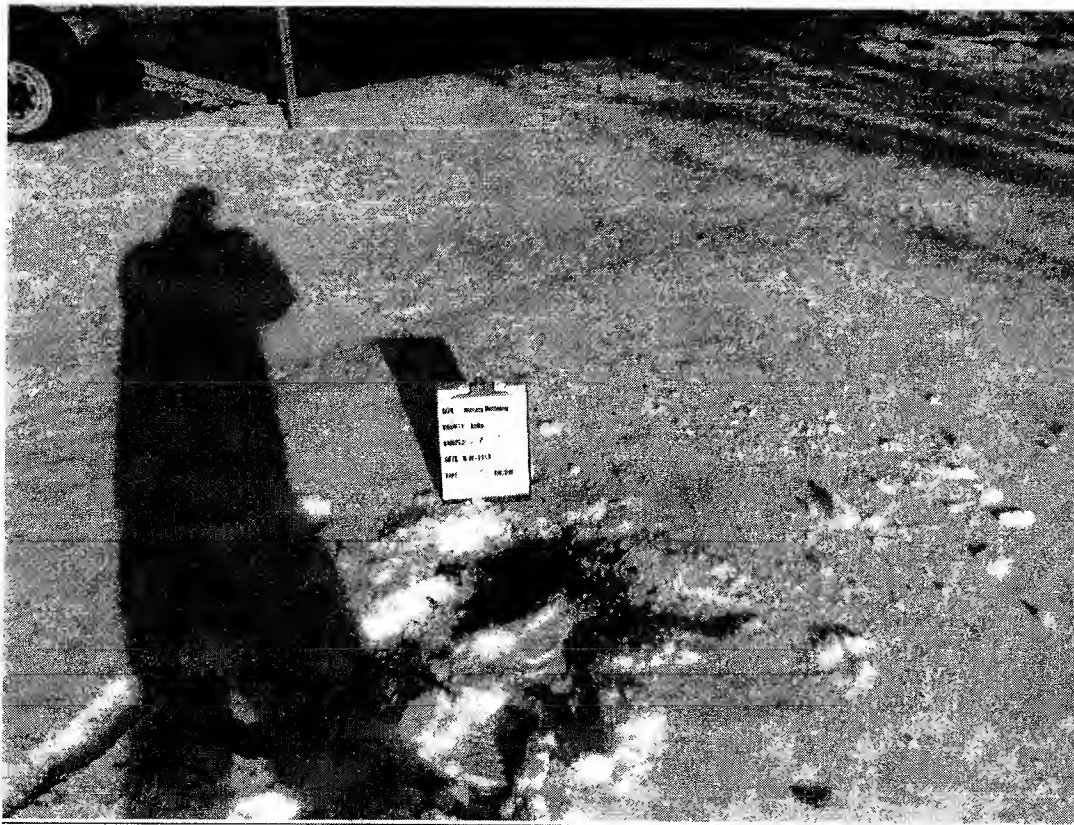
Site:	Metals Refining Site
Site ID:	INN000509964
Date:	1/19/10
Weather:	Cloudy Cold
Sample ID:	BK7
Sample Type:	XRF Soil Screening Sample
Description:	Sample was collected in Triangle Park off May Street
